Longwall Integral Isolation Block

Integral Isolation Block – Double Block and Bleed

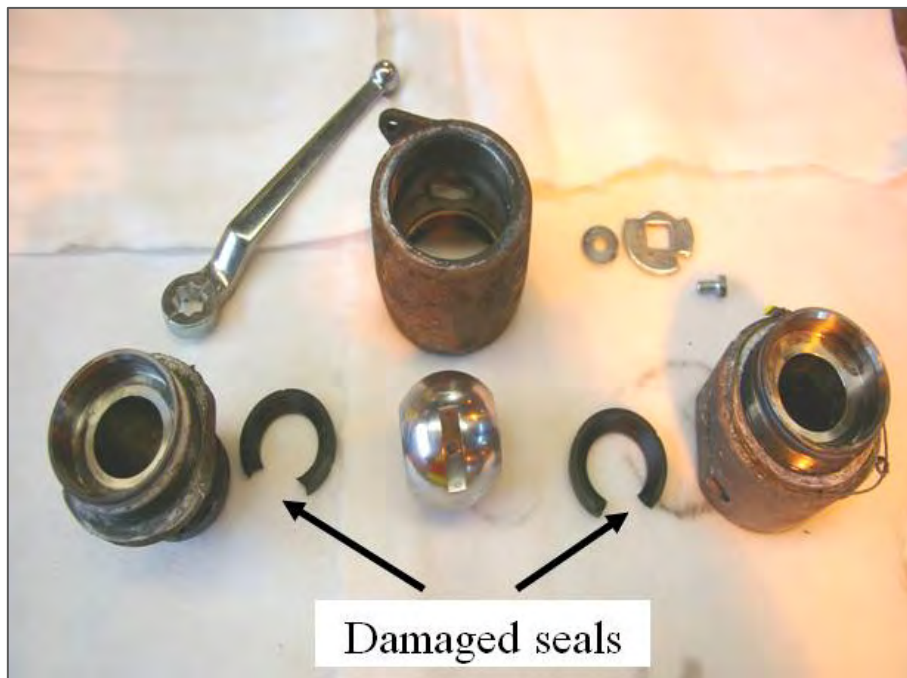
Figure 1 - Damaged Ball valve dismantled showing damage to seals

1. Faulty isolation equipment
2. Poor verification methods to prove isolation
3. Shock damage to components from hydraulic pressure spikes
4. Damage caused to ball valves by 'throttling' the pressure when restoring pressure to the system (see figure 1)

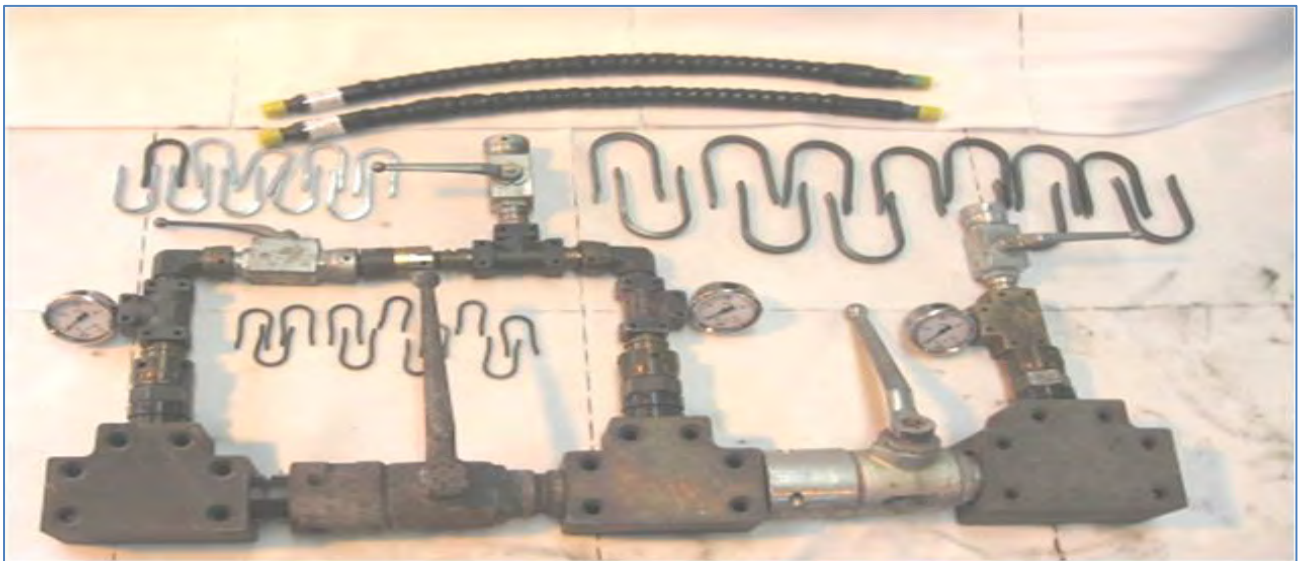
To achieve what has been recommended by the Department of Primary Industries with individual components you would need the following

We would suggest that this would be an unacceptable installation which would further increase the hazards which workers are exposed to, extra hoses, staples, fittings etc. It would also increase the maintenance requirements to ensure the safe and reliable function of the system.

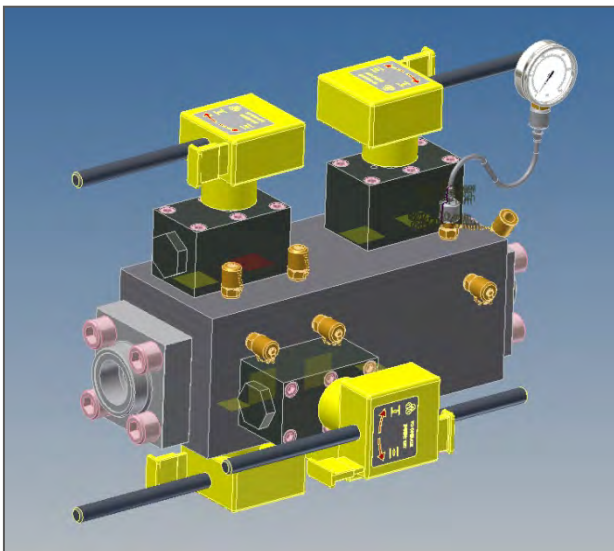
Figure 2 - Integral Isolation Block with locking actuators

As a stand alone unit, the integral isolation block addresses all the issues identified above and in the Mine Safety Alert. It has double isolation, pressure dissipation, verification of both isolation points, and slow pressure rise for re-energising the system in a controlled manner. ‘Fortress’ locking actuators allow keyed sequenced operation to ensure that the isolation and restoration can only be done in the correct sequence. Normal Handle type actuators can still be locked for isolation.

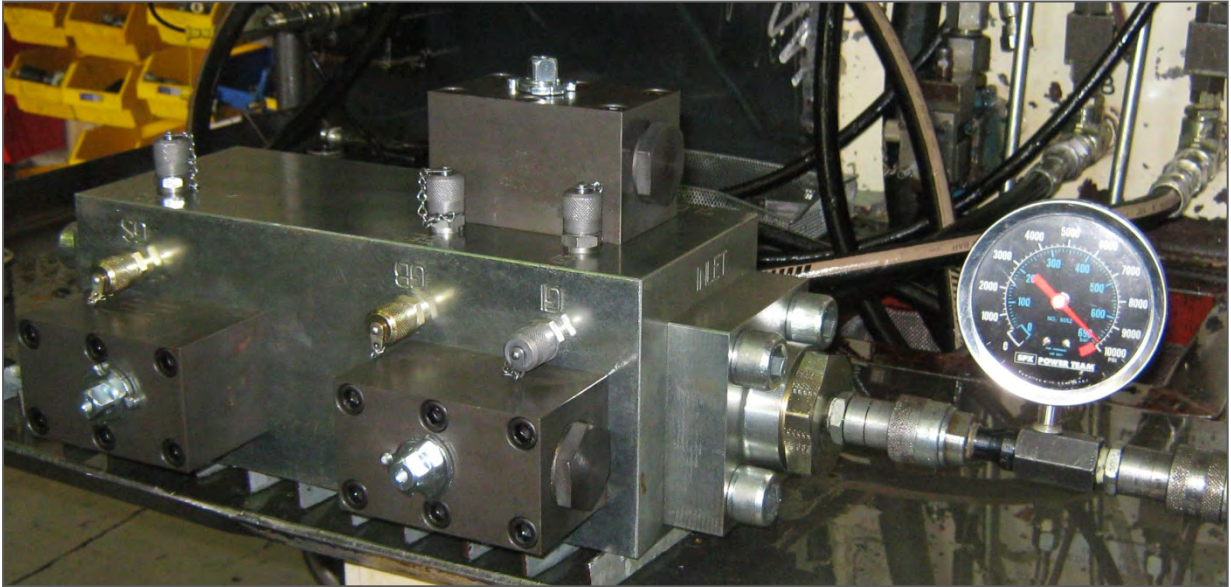
Figure 6 - Complete Block during testing at 10 000PSI

The Integral Isolation Block has had a Finite Element Analysis completed to prove reliability and strength of the unit – this FEA has allowed a Factor or Safety greater than 4 to 1 at 450 BAR. Each unit is static tested to 700 BAR during the manufacture process.

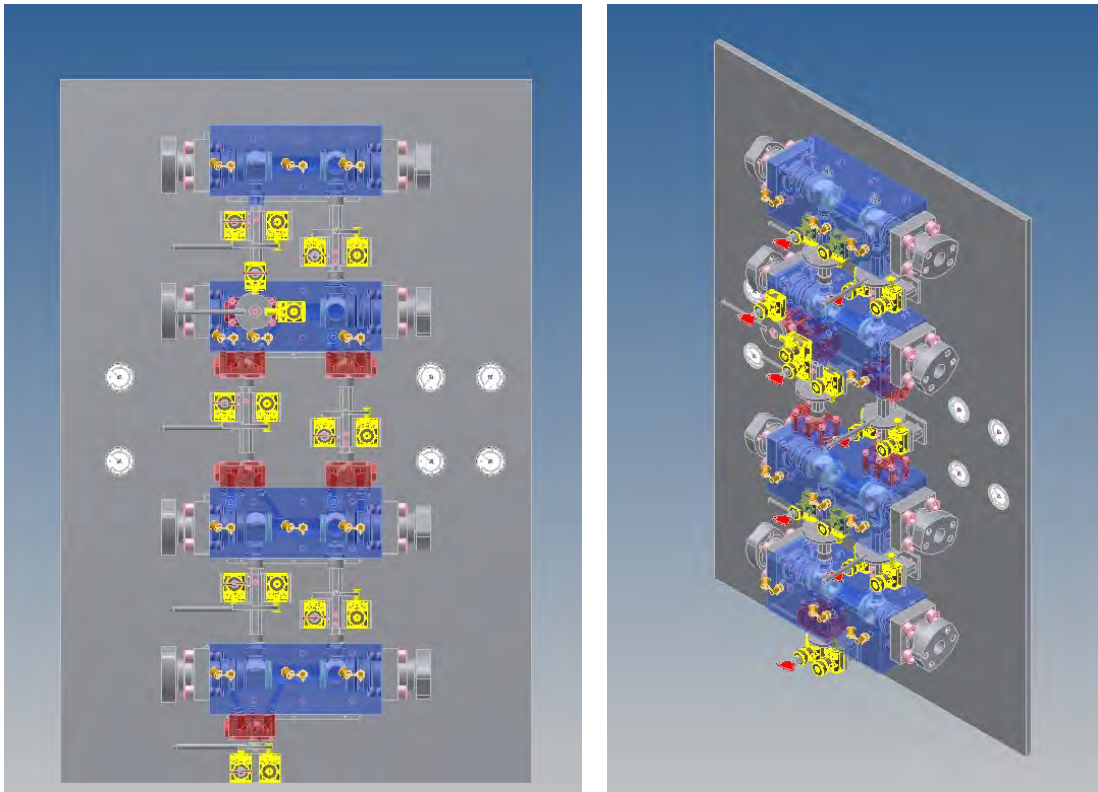
Figure 7 - Isolation Board concept for 4 incoming supply lines

The Integral Isolation Block can be used in multiples to allow isolation of multiple incoming supply lines in one location, still using Fortress type locking actuators to ensure correct sequence of the total process.

This page shows a schematic representation of the above isolation board, this system uses 3 low pressure pumps for normal operation and 1 high pressure pump for High Set circuit used on this particular longwall system.
